Re-Inventing the Liberty Cap – Part 1

by Kip Lankenau

This article first appeared as a series in the *Torque Meter*, Journal of the Aircraft Engine Historical Society in Summer and Fall 2006 publications.

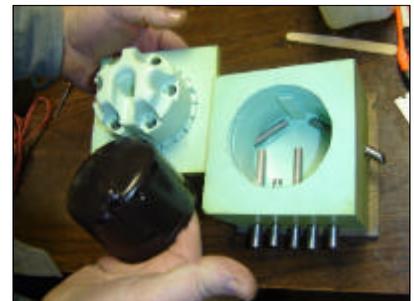
Distributor Cap Production

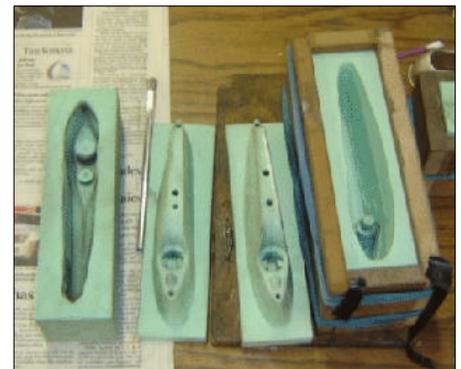
Metal casting moulds for Metropolitan door handle

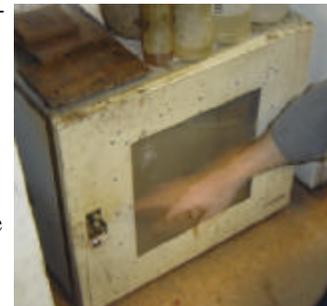
Process begins with a mould (left).

Pouring phenolic resin (right)

Bake mould in oven (right).

Moulds ready after baking (left).

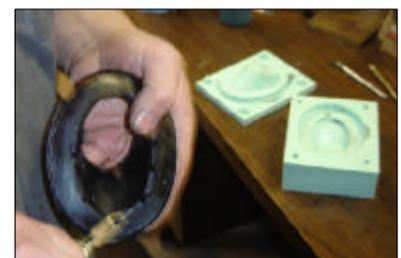
*Above: taking top of mold.
Right: popping out product (in this case, a rubber fuel casket).
Below: trimming nubbins.*

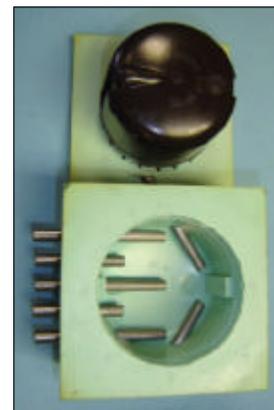
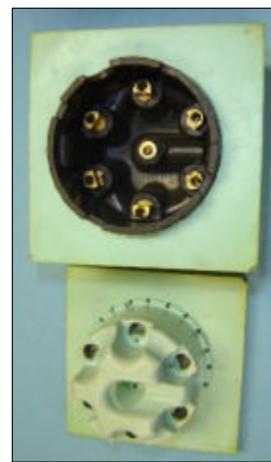
Sample of a reproduction distributor cap. Made in small batches, caps are concourse quality.

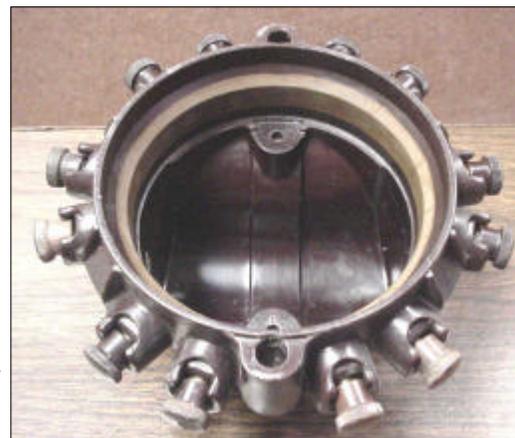
The original pattern Liberty distributor cap. Note the asbestos high tension ring.

For days we looked over the broken pieces and the complete cap, analyzing and debating how it had been made and pouring over the various manuals we'd collected, trying to understand and speculate why they were made the way they were. An interesting early observation was that the high tension contacts had been cast into an asbestos ring and machined. This contact ring was then placed into a mould and the cap cast around it. Was this asbestos ring essential? If so, it would require an additional set of moulds and we'd need to develop a suitable asbestos casting material. Careful examination and comparison of various manuals led to the conclusion that two different types of ignition rotors were used; an early type with a spring-loaded carbon brush, and a later type with a fixed metallic brush of which we had a sample. With the spring-loaded carbon brush type rotor, the carbon brush actually ran in continuous contact with the high tension contact ring, necessitating a close tolerance machined surface. The asbestos was required to withstand the heat and wear caused by the constant brush contact. This early rotor type was obviously a design weakness quickly remedied with the introduction of a fixed brush type rotor. The new type rotor no longer required the asbestos brush track, but as the cap was already in production and would work with either rotor type, no cap change was apparently warranted. By understanding why it was made, we were able to determine that the asbestos track would not be required on our new caps, as long as the later rotor type was used, thus allowing a single mould and a monolithic casting.

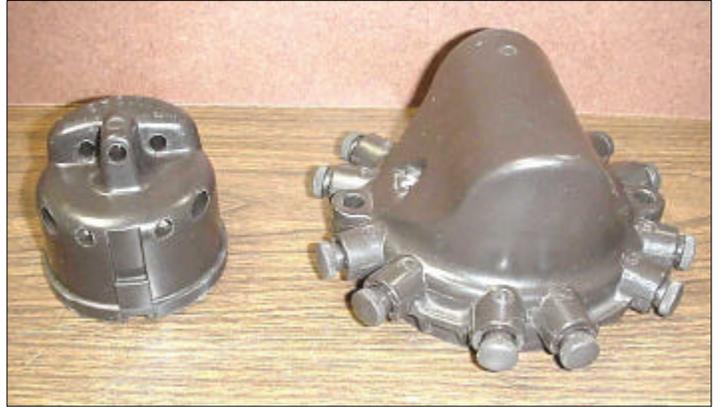
Our most complicated cap to date was the 6-cylinder Lucas cap. It dwarfs in comparison to the Liberty pattern distributor cap.

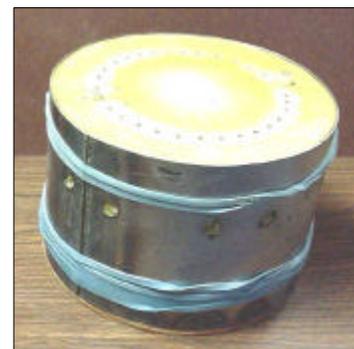
Mould shell ready to pour.

It was early in the morning when we loaded the twelve threaded nylon tubes with brass high-tension contacts and carefully put them into place in the two assembled exterior mould sections. A predetermined amount of the viscous phenolic mixture was slowly poured into the partially assembled mould to avoid creation of air pockets or bubbles. With the phenolic now in the mould, the large inner mould section was placed on top and slowly pushed down until fully seated on the outer sections. The threaded nylon tubes containing the high-tension contacts were then pushed in until the face of each contact seated against the interior mould. The entire steel wedding cake appearing monstrosity was then pressurized and baked.

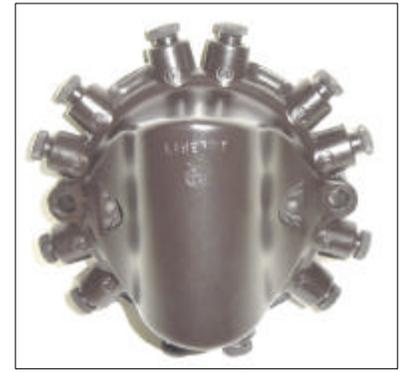
Our first Liberty reproduction cap!

The preparations and casting process of the previous day were repeated. If all went well we would leave for the fly-in early the next morning. We began stripping the new cap from the mould with great anxiety. When the time came to remove the threaded nylon tubes, we all held our breath and listened for that telltale cracking sound that meant we'd failed again. One by one they came out and no cracks. A sigh of relief came over us as we looked at each other in disbelief. We'd done it! Careful examination of the cap confirmed it was virtually perfect, no flaws, no bubbles. Very minor finishing was required to remove a little flash, the casting vents and clean up the face of the high-tension contacts. As our hands ran over it we realized what we were touching, the first new Liberty engine distributor cap produced in over eighty years!

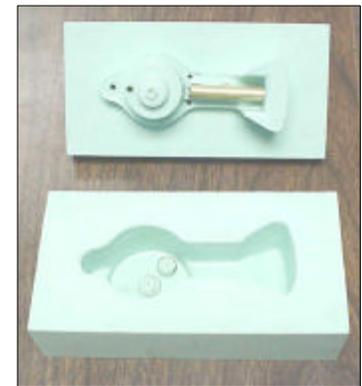
Open Liberty Distributor Rotor Mould

A silicone mould of the pattern rotor was made in our conventional fashion using high density particle board for the mould casing. We opted to pour the casting with the rotor metal base at the bottom of the mould. A 10-32 screw through the top of the mould sufficed to locate the threaded insert, but holding the brass brush tight to the top of the mould took some thought. We eventually decided to attach length of

fine solder wire to the center of the brush. A hole was then punched in the top of the mould through which the solder wire passed thus holding the brush tight against the underside of the top of the mould. Actual casting of the rotors was very straight forward and uncomplicated, requiring only minimal work to remove flashing and vent stubs.

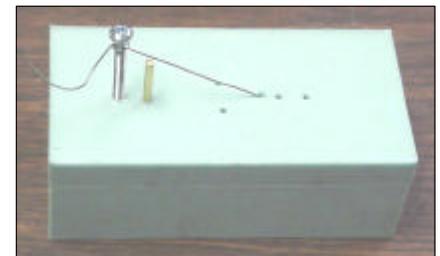
Closed Liberty Distributor Rotor

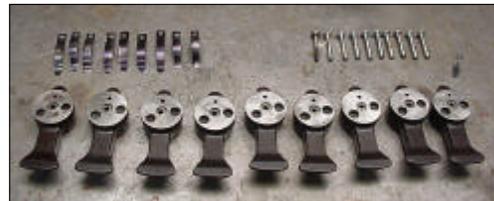
Finished rotor components

The fixed brush of our pattern rotor consisted of a hollow brass tube with what appeared to be a tungsten tip. Doubtlessly durable, we reasoned such a tip would survive long after all other ignition components had failed (to say nothing of the engine itself!). This potentially costly feature was quickly discarded and replaced by a brass brush cut from solid round stock and tapered at one end.

One rotor component kept us scratching our heads for a simple solution, the spring brush/coil contact. This small piece of spring steel was a critical element, but even if we decided to make a large run of rotors, very little material would be required. Finding a small amount of spring steel of the proper gauge ended up being more like a scavenger hunt than a thought out procurement decision. We scoured the shop in search of suitable material; pallet banding strap (too thick), ignition feeler gauge (right size but what a waste with only one useable piece of the right thickness per tool), band saw blades (too thick), etc. One evening, just before bedtime, Dave called with excitement in his voice "Steel tape rule spring!" Before I'd reached the shop early the next morning, Dave had already dissected a steel tape rule. Sure enough, the retracting spring was just the material we'd been looking for and in a quantity far in excess of our requirements. Once cut, punched and bent into shape they were the finishing element to the rotor assembly.

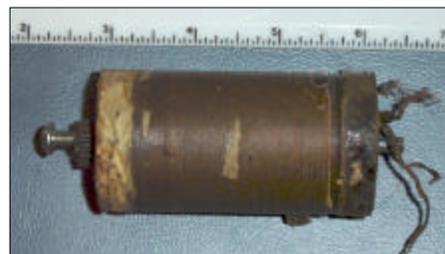
Original Liberty Distributor Coil

Digital photos were taken of the coil plate before removing the coil and during the disassembly detailed notes were made to record stacking order of the numerous sub-components. Removal of the coils' phenolic end caps required soaking in mineral spirits to soften the eighty year old varnish and potting compound. Once free of the end caps, the varnish encrusted bobbin wound bare coil and wire ends were clearly visible.

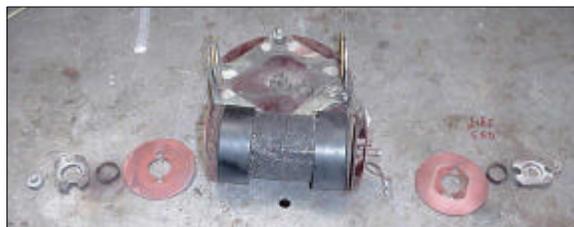
Disassembled Liberty Coil

Again, mineral spirits was used to soften the varnish covering the coil windings. Due to the very fine and fragility of the wire used, it took Dave and John almost a full day to unwind a single layer, 500 turns of 38 gauge copper wire. With no appreciable decrease in the overall coil diameter, we decided to abandon our initial plans to hand wind the coils and to find a specialist to complete unwinding the original and then to machine wind the new coils.

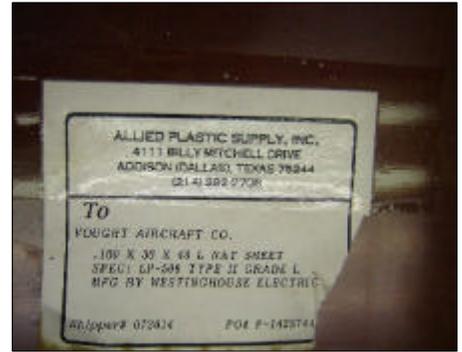
Original Phenolic Sheet

We'd already decided it would be necessary to mill oversize stock to the correct thickness, when on a whim Dave decided to stop by a supplier we'd used before that handled overstock and reclaimed plastic. A description of our needs to the man behind the counter immediately set off light bulbs. He disappeared out back and shortly returned with a nearly four foot square sheet of material identical to the original! He then went on to explain that this stuff had been around forever and they'd given up hope of ever selling it. For a small amount of pocket change this piece changed hands, whereupon the counterman promptly said he had another sheet as well if we could use it. In disbelief, Dave returned to the shop to show off his prize. It was then we noticed a very old tag attached to one corner of the sheet "Vought Aircraft Company".

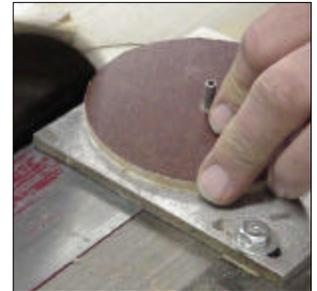
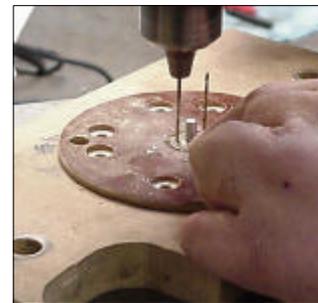
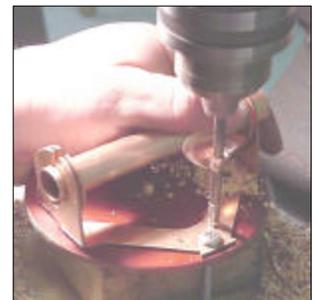
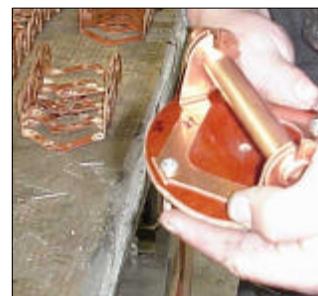
Coil Baseplate Fabrication and Assembly

The phenolic was first cut into squares on a table saw before drilling the center hole for the carbon brush. Using this hole as a pivot, a simple jig was set up again using the table saw, this time to cut the squares into circles. This same jig was then transferred to the mill and used as a center to countersink each piece for the carbon brush retaining plate.

From this point forward, each coil plate became a hand fitted assembly with all pieces sequentially marked and matched. With a matched set of copper coil brackets held to it's piece of phenolic, the same mill and jig were used as an off set pivot to drill through both copper and phenolic in eight different locations for the retaining rivet holes. Each of these holes through the phenolic was then countersunk for the rivet heads. The carbon brush plates were drilled in a similar fashion.

Copper rivets were then used to attach each phenolic plate to it's corresponding set of coil brackets, each rivet then also soldered to it's copper plate. The carbon brush and brass retaining plates for each were placed, then pinned through using brass push pins which were also soldered into place. Small amounts of the same phenolic mixture used to make the cap, knobs and rotor was used to fill over the recessed rivet heads. Each plate and bracket assembly was then hand fitted to a new cap and minor adjustments performed as required. As there is no variation between the caps themselves, once thus fitted the coil plates are interchangeable and will fit any cap.

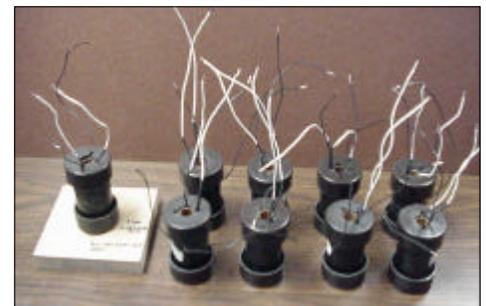
Coils potted using jig.

A jig was made to hold the coil and end caps in alignment while the silicone used as the potting compound cured. With end caps in place, the core is then inserted; lengths of .050 piano wire surrounding a .250" diameter rod threaded at each end. Layers of steel shims, varnished paper washers, short insulating tubes and a stamped steel lockplate are used to hold the coil fast to the copper retaining brackets of the coil plate. Once assembled one last check is made for shorts before soldering the coil wires in place. Assembling and soldering the coil to the coil plate is particularly challenging and requires more fingers and hands than possessed by the average human. Correct stacking of these components is critical as engine vibrations would quickly short out an improperly or marginally assembled unit.

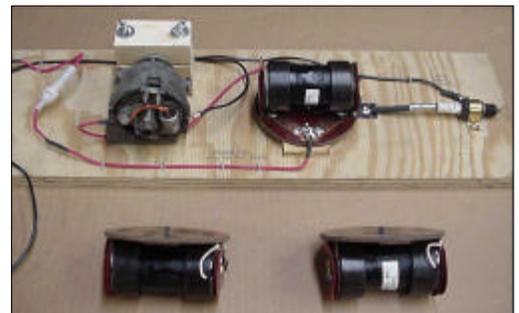
Coil Test Rig

It was difficulties in this final process that drove our decision to design and build a testing device. This simple rig, consisting of an old distributor with contact set and condenser, spark plug, brackets, wire and a few clips attached to a piece of plywood, uses a six volt battery and provides a simple go/no go test for each coil plate assembly. Once tested, the coil plate assemblies are ready to be installed in a distributor cap and soldered into place.

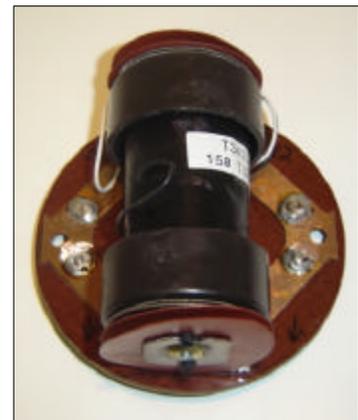
Finished Coil and Plate Assembly
